Quiet Creek

Elkhorn / Las Delicias 10 year

Elk/LD 10 years - some remote sensing

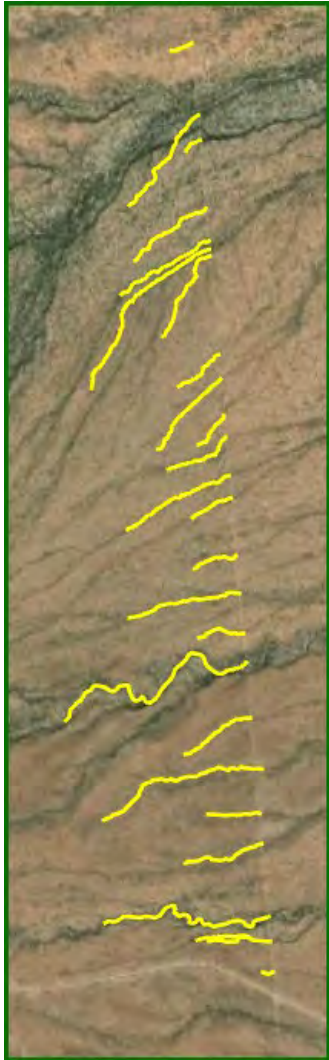
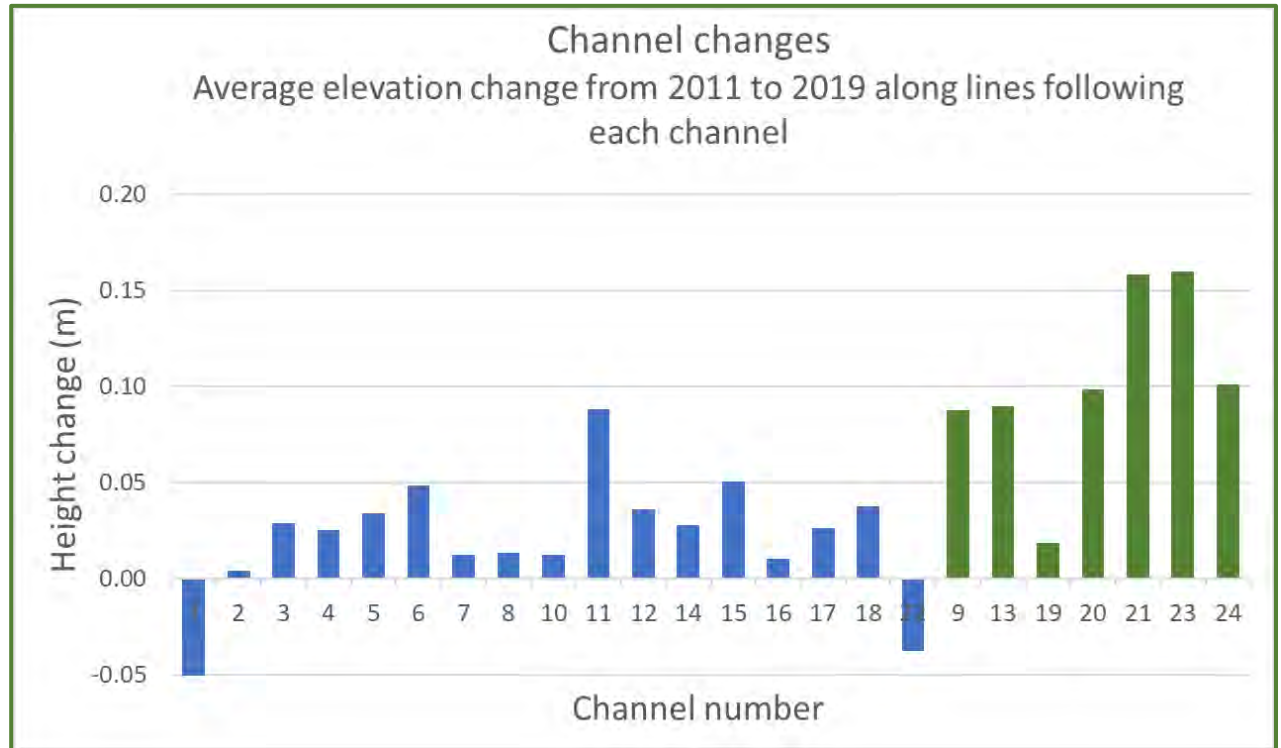
Average change in channels

- Not treated (ex. Road)
- Treated

Combined vertical RMSE of both lidar 14.2 cm

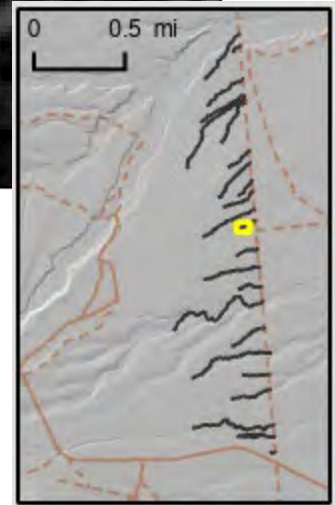
Channel 13

2011

2019

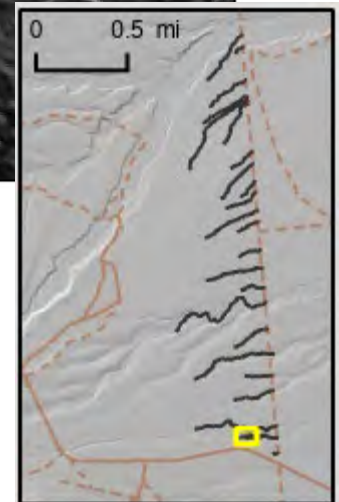
Channel 23 incision

- Incision appears to have reduced
- New headcut forming

2011

2019

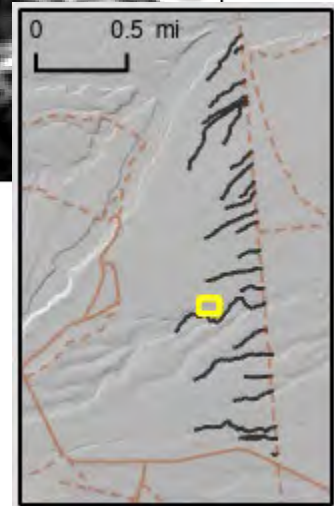
Channel 17 digits

2011

2019

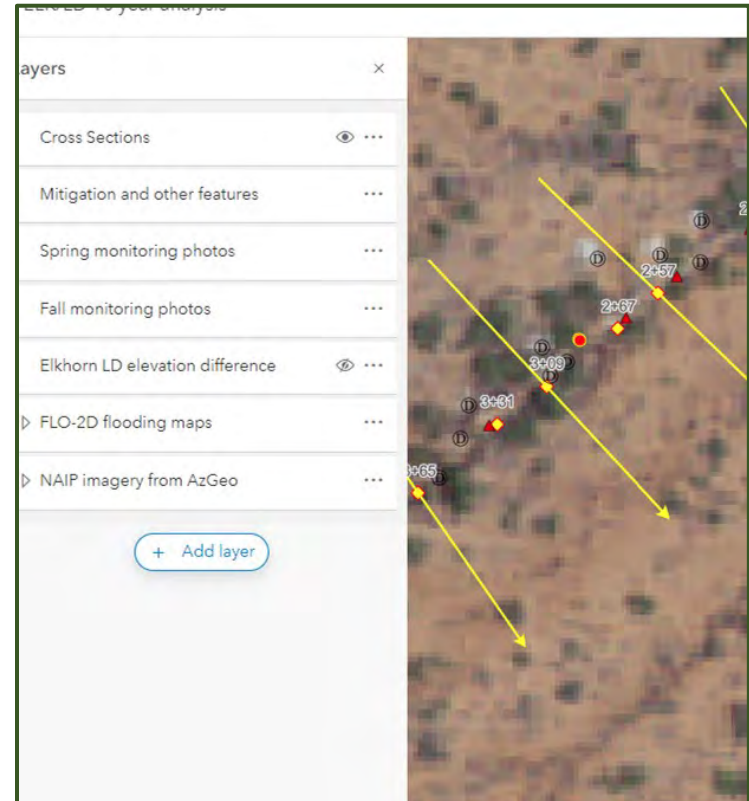
- Putting it all together in a publicly available web map
 - Surface changes
 - Cross sections
 - Structures
 - Photo points
 - FLO 2D models
 - Edge imagery
 - NAIP imagery from 2013, 2015, 2017, 2019

Screen shot of the online map
