RESTORATION

Cuenca de los Ojos: Three Decades of Restoring Water Flows on Private Land in the U.S. and Mexico

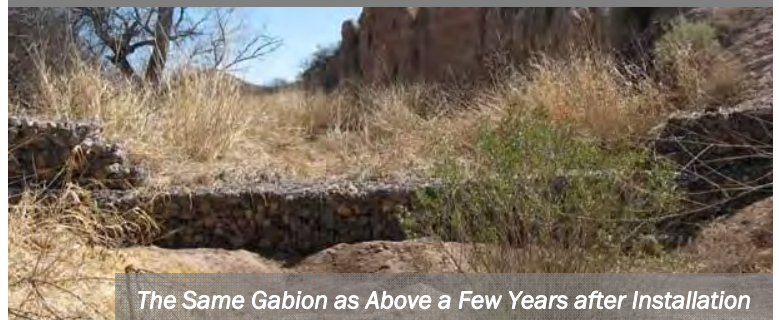
The Same Gabion as Above a Few Years after Installation

After 20 years, changes in the landscape were obvious—hillslopes retained moisture with pools of water present in dry months; in washes, sediment deposited around the structures and caused streambeds to rise; vegetation grew more densely; wildlife benefited from the increase in surface water; and in Mexico, a once dry stream is now perennially flowing for 8 miles.

Increased sediment and moisture retention near structures creates conditions where vegetation can establish and thrive. The roots and canopy of perennial plants help stabilize hillsides and streambanks, eventually removing the need for continued management. For example, when a 500-year flood event in September of 2014 caused some gabions to wash out, vegetation that had established behind the gabions helped stabilize the channel and prevent further erosion.
