Habitat Restoration within the Middle Rio Grande of New Mexico

US Army Corps of Engineers®
Albuquerque District

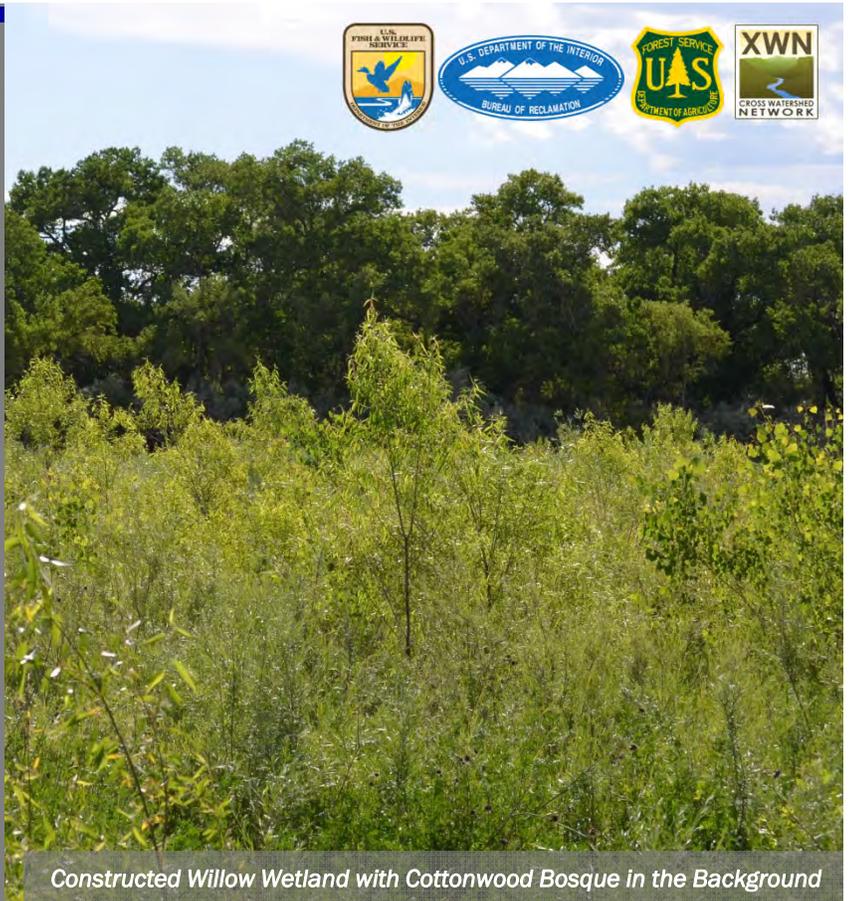
Constructed Willow Wetland with Cottonwood Bosque in the Background

Enhanced Hydrology: Nearly 50 moisture-enhancement features were constructed. Excavation was used to reduce depth to groundwater and promote regular, seasonal flood inundation of willows and other wetland plant species.

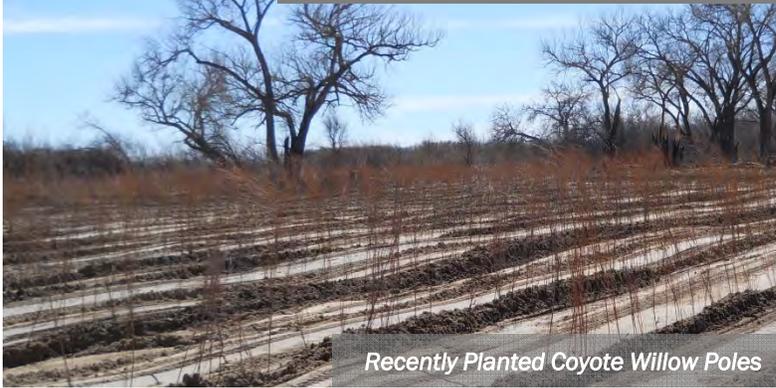
Recently Planted Coyote Willow Poles

Revegetation: Approximately 127,000 potted shrubs, 9,000 tree poles, and 345,000 willow cuttings were planted. Native grasses were seeded along levees, spoil areas, and reclaimed access roads and herbaceous plugs were installed in wetlands.

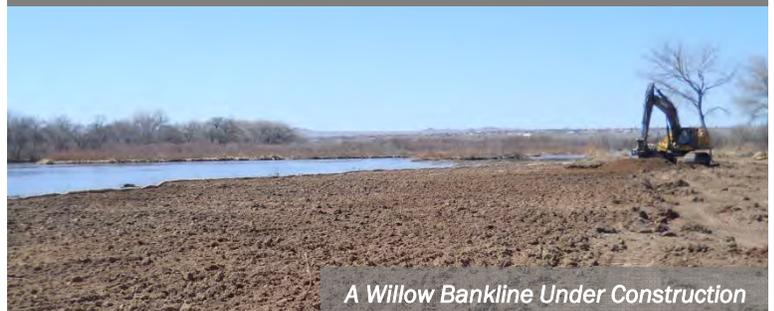
A Willow Bankline Under Construction
