## RESTORATION

# Irrigation of Riparian Habitat Restoration along the Rio Grande Canalization Project

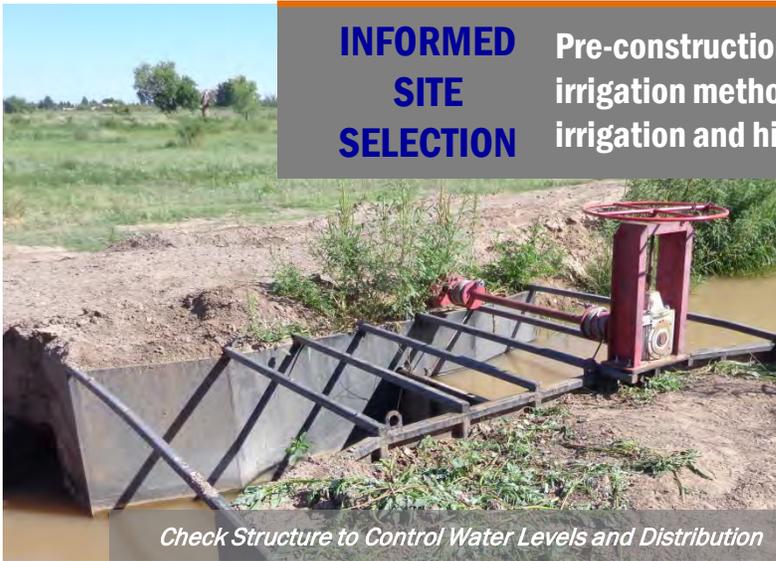
*Check Structure to Control Water Levels and Distribution*

**Water Delivery Infrastructure:** In 2017, USIBWC and EBID entered into an agreement to build irrigation infrastructure for two additional sites. Construction was completed in 2018. These sites were irrigated using different delivery methods, one a gator pump and the other a check structure to divert water. Both sites are located upstream of the existing irrigation ditches, so large (12"-diameter) PVC was used to pipe water upstream.

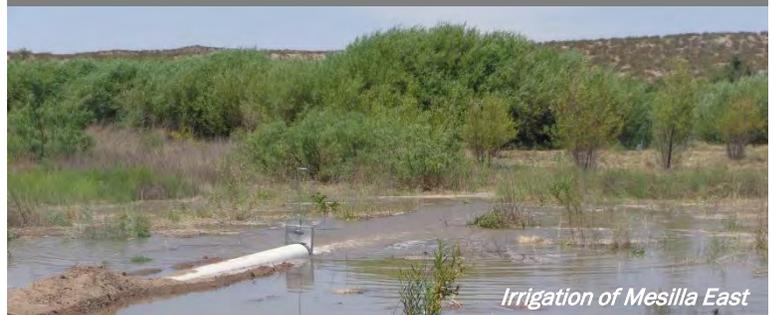
*Irrigation of Mesilla East*
