HABITAT CONNECTIONS

US Highway 93 Wildlife Overpasses: Promoting Highway Permeability and Safety for Desert Bighorn Sheep

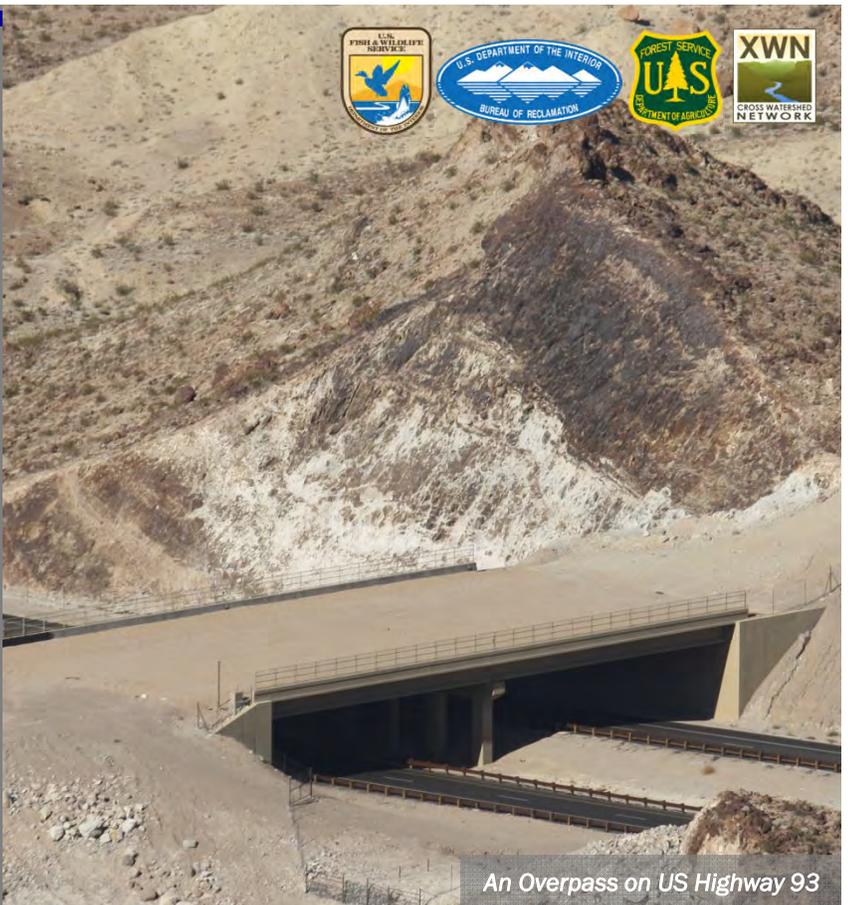
An Overpass on US Highway 93

Strategically-Located Overpasses: Pre-construction monitoring showed that bighorn were primarily utilizing elevated ridgeline areas for highway crossing, likely due to sheep’s preference for wide range of visibility. These naturally elevated areas were strategically selected as overpass sites.

Multiple Crossing Options: Crossing features included three wildlife overpasses with exclusionary fencing to guide sheep to the overpasses and to additional drainage structures (three culverts and the dry washes under two bridges).

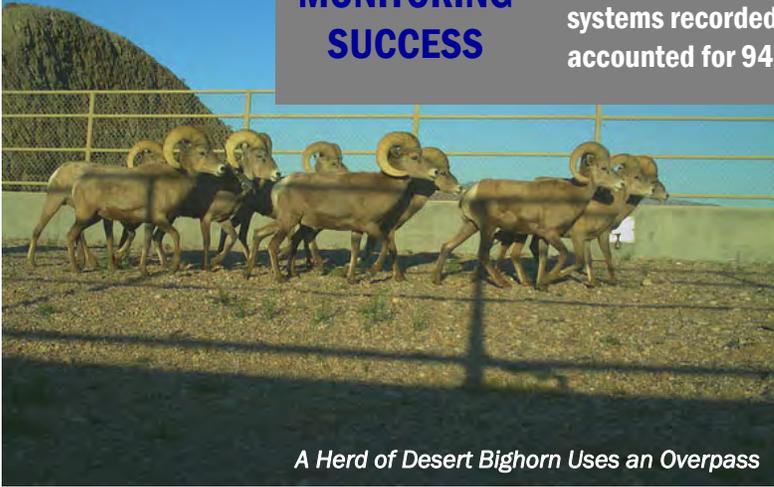
A Herd of Desert Bighorn Uses an Overpass

Over a 4 year period after installing wildlife crossing features, the camera systems recorded 15,134 crossings by nine species. Desert bighorn sheep accounted for 94 percent of all animals documented at the structures.

90 percent of the sheep crossings occurred at the overpasses, with far fewer sheep utilizing dry washes under the bridges and at the culverts. This is likely due to the sheep’s preference for wide-ranging visibility and ridgeline habitats.

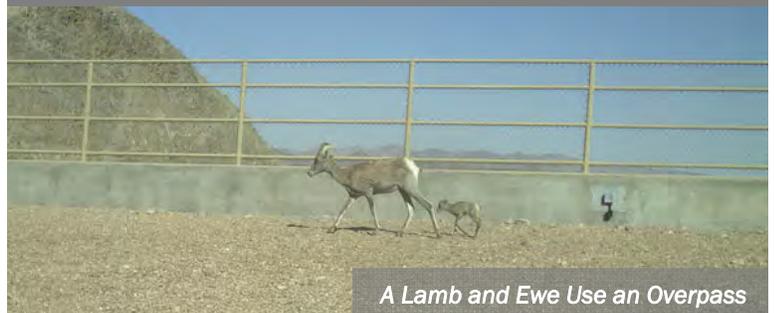
A Lamb and Ewe Use an Overpass
