RESTORATION

Riparian Woodland and Grassland Restoration to Increase Resilience to Drought

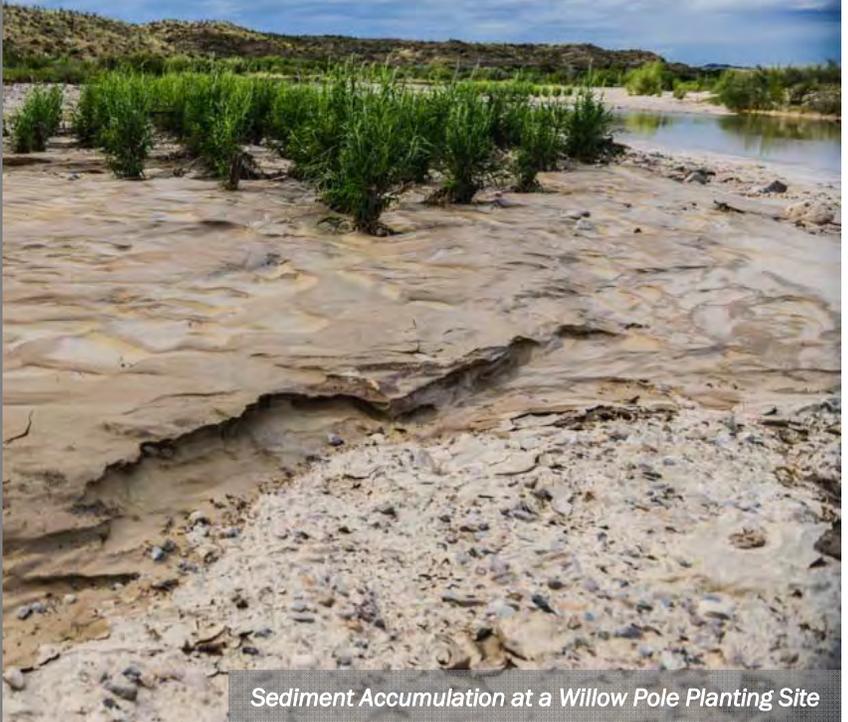
Sediment Accumulation at a Willow Pole Planting Site

Successful willow establishment improves riparian and aquatic habitat. Revegetation has led to fine sediment accumulation and channel aggradation which improves the depth and extent of the aquifer. Revegetating degraded wetlands located on private land near the headwaters can create nursery conditions downstream and enhance natural regeneration of riparian woodlands.

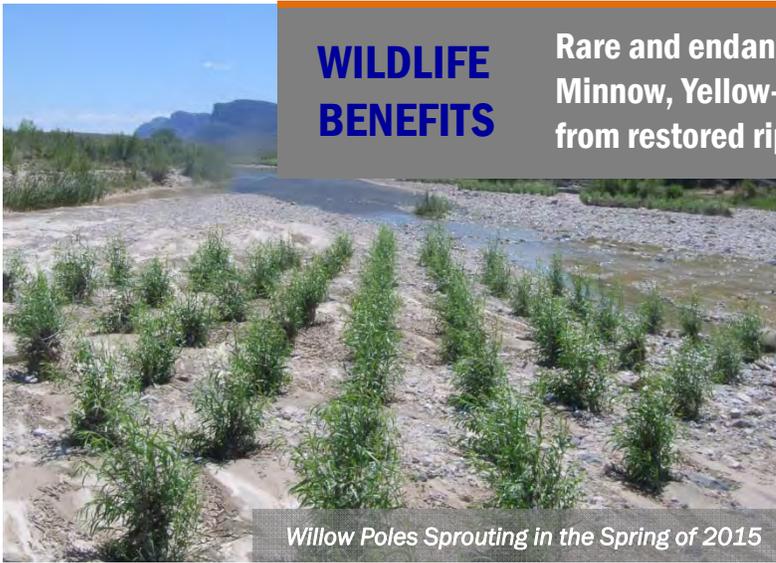
Willow Poles Sprouting in the Spring of 2015

Revegetation Protocols: Planting pre-soaked willow poles in bundles of three in diamond-shaped planting areas has been shown to reduce scouring.
